Manhole Inspection Summary

Manhole # S71A1_006MH

Insp Date: **2/18/08 10:09 AM**

Location Address: **6700 Cameron Dr.**

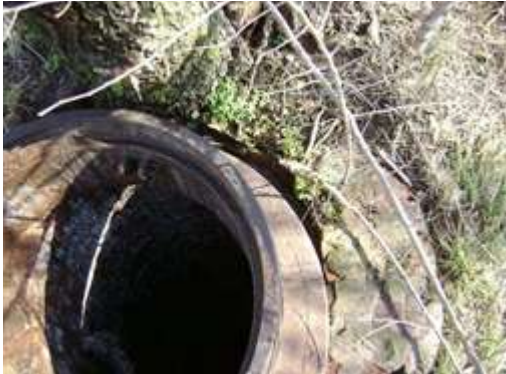
Defect 2

Comments **FRAME IS VERY OFFSET. THE MANHOLE IS RIGHT NEXT TO A LARGE TREE. NO ROOTS SHOWING IN BARREL, YET.**

Offset: **8** (in.)

Severely offset frame.

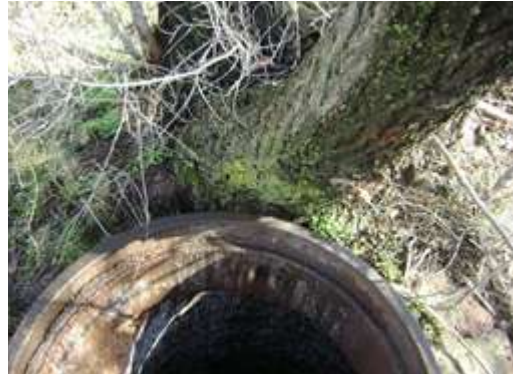
Defect 1

Frame loose and up against tree

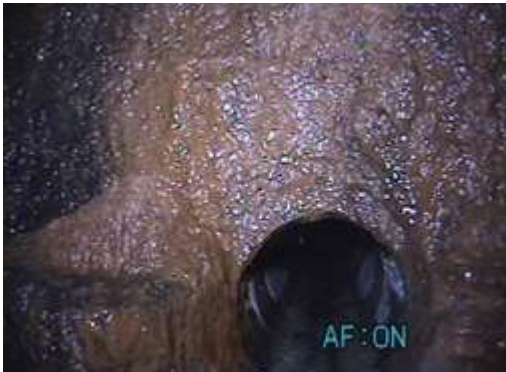
Defect 3

Infiltration: ☐ None ☐ Joint ☐ Cracks ☐ Mortar ☐ Roots ☒ **Wall**

infiltration in barrel above incoming 7 o'clock

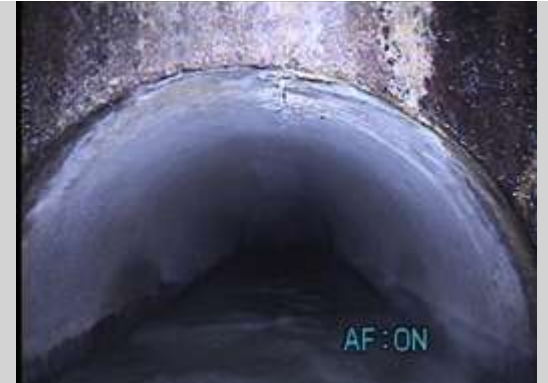
12 O'Clock Outflow

Pipe Height: **30** (in.) Rod and Bar (Angled)
Pipe Material: **Clay** ☐ Pipe Lined
Invert Depth: **23.83** (ft.) Flow Characteristics: **Fast**
Deposits: ☒ None ☐ Mud ☐ Sludge ☐ Debris ☐ Grease
Silt Depth: (in.) Deposits Extent:
Infiltration: **None** Pipe Seal Cond: **Sound**

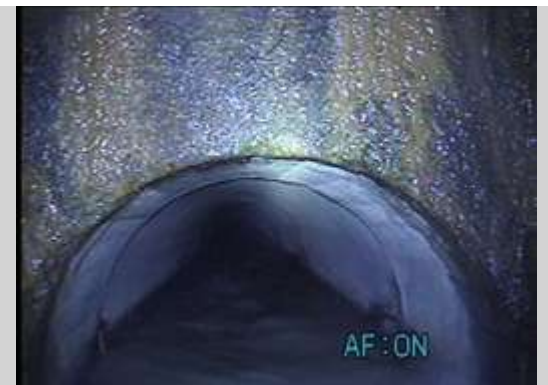
6 O'Clock Inflow

Pipe Height: **30** (in.) Rod and Bar (Angled)
Pipe Material: **Clay** ☐ Pipe Lined
Invert Depth: **23.75** (ft.) Flow Characteristics: **Fast**
Deposits: ☒ None ☐ Mud ☐ Sludge ☐ Debris ☐ Grease
Silt Depth: (in.) Deposits Extent:
Infiltration: **None** Pipe Seal Cond: **Sound**

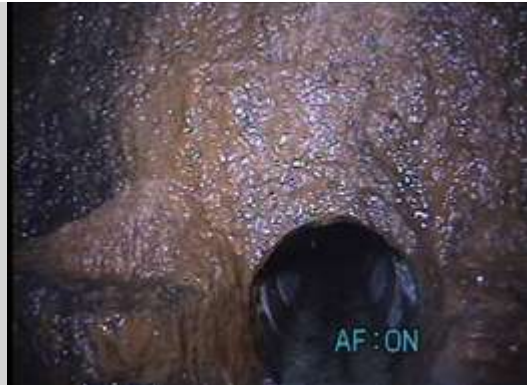
7 O'Clock Inflow

Pipe Height: **8.4** (in.) Rod and Bar (Angled)

Invert Depth: **22.33** (ft.) Flow Characteristics: **Slow**

Infiltration: **None** Pipe Seal Cond: **Sound**
